Report to the Royal Commission
Stairs and Access Ramps between Floors
in Multi-storey Buildings

Des Bull

Technical Director, Holmes Consulting Group Ltd

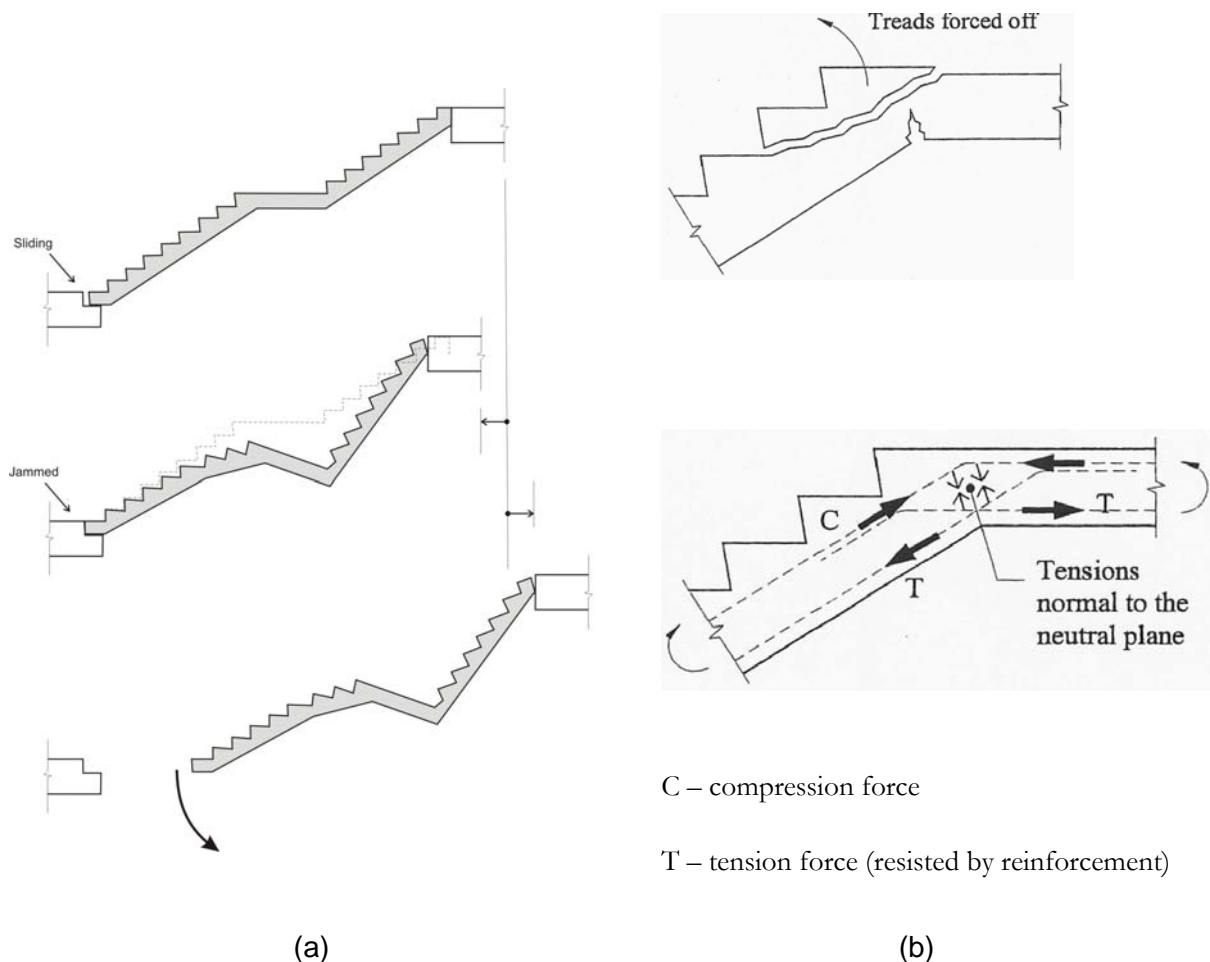
- (a) Relative movement between floors causes the stairs or ramps to compress and can lead to a permanent shortening of the stair. On the reversing cycle of the earthquake displacements, there is insufficient width of support remaining and the stair falls.

- (b) Should a stair or ramp, which is straight (not the scissor stair described below), have a mid-height landing, then it is possible for the front part of the mid-height landing to fail. This was documented in a site accident with a precast concrete stair in the 1980s by Andrews and Butcher (1988) and extensively researched, with recommendations for improved performance, by Simmons and Bull (2000). It is called an “opening knee” failure and is where the top of the landing at the first step is squeezed off as the top of the stair is compressed.

Figure 1: Interstorey drift along the stair: (a) compression forces a shortening of the stair and (b) the knee of the stair/landing “opens” and the landing fails.

In Figure 1 describes the issues (a) and (b) above.

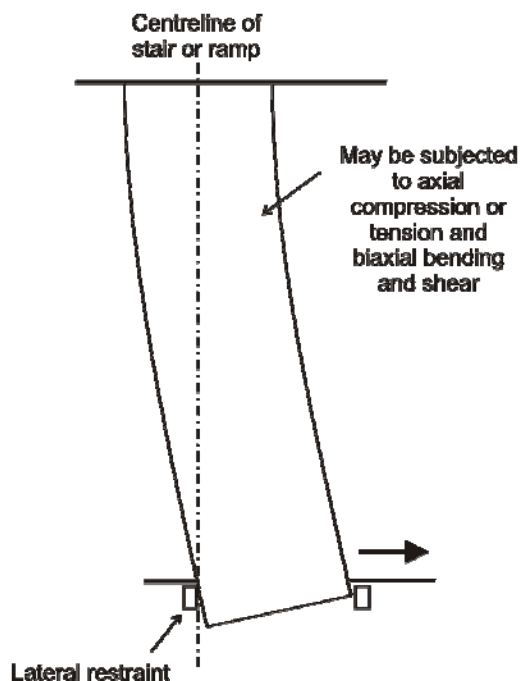
Relative movement between floors across the main axis of the stair or ramp causes the stair or ramp to be subjected to compression or tension along the main axis of the elements as well as bending and shear due to gravity and bending and shear in the plane of the stair or ramp. The bending and shear in the plane of the stair or ramp occurs because either the stair or ramp is built-in at both ends or if the stair or ramp has a sliding end which is restrained transversely to the main axis (direction of sliding). There is a further case where the stair or ramp is free to move both along and transverse to the main axis of the element. Here, the stair or ramp acts as a cantilever about the fixed end. See Figure 2.

Figure 2: Interstorey drift across the stair or ramp.

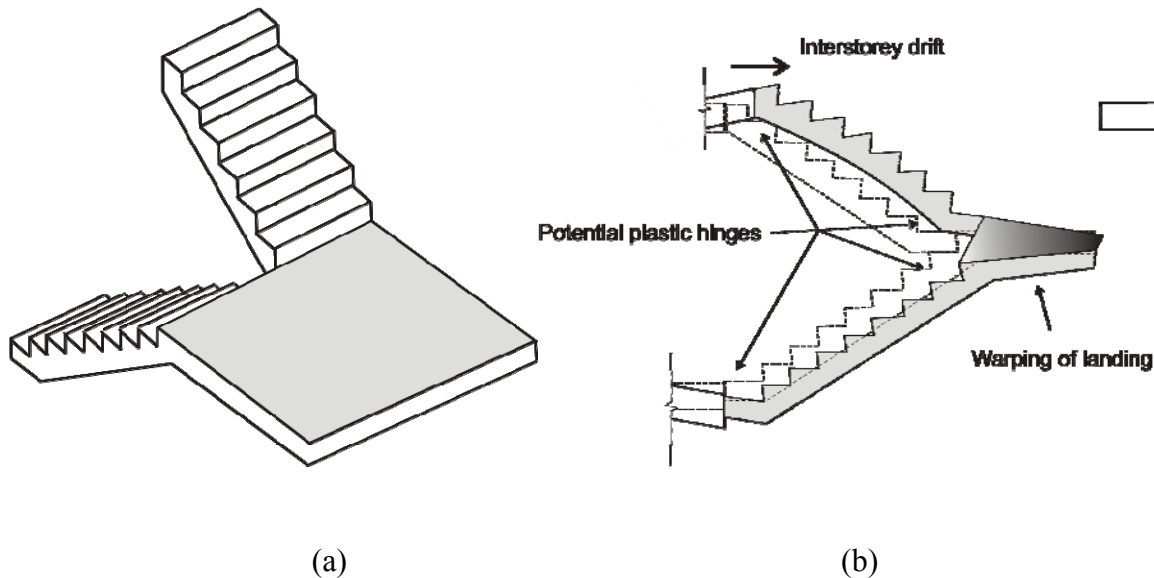
- The supports at each end of the stair or ramp rotate relative to each other. This has been seen in the Christchurch earthquake and elsewhere, where stairs are attached to walls and one end (the wall) is lifted and twisted relative to the other end of the element, as the wall displaces laterally (resulting in either rocking of the wall or a vertical lengthening due to yielding vertical reinforcement in the wall).
- “Scissor” stairs: in a stair that has a mid-height landing and the stair turns back on itself (that is not a straight element), interstorey drift between floors can cause overstressing of the stair assembly in a number of locations. Torsion along the longitudinal axis of both flights as well

as across the mid-height landing. See: Figure 3 (a) stair layout, (b) distorted stair with plastic hinges and warping of landing.

Figure 3: Scissor Stairs
